VINGT- DEUXIÈME CONGRÈS
DES GRANDS BARRAGES
Barcelone, 2006

**EILDON PROJECT ALLIANCE DELIVERS COST EFFECTIVE SPILLWAY
CAPACITY UPGRADE (*)**

Shane McGRATH
Manager Dam Improvement, Goulburn-Murray Water

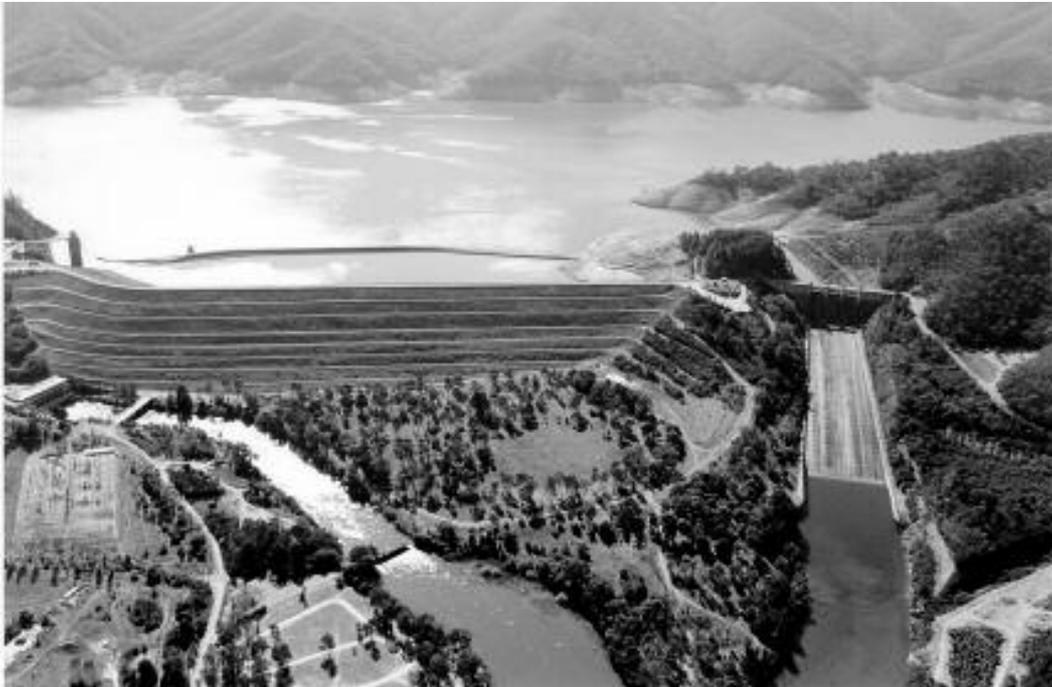
Figure 2
Aerial View of Eildon dam
(Vue Aérienne du barrage d'Eildon)

The spillway is located on the eastern (left hand) side of the embankment. It is a mass concrete structure with a height of 33 m in the ogee section and 40 m in the non overflow section and a crest width of 200 m. The overflow section of the structure consists of 3 bays each approximately 20 m in width. The approach channel to the spillway was excavated through the left abutment of the dam. It is unlined. The total length of this excavation is about 900 m with the structure located about 425 m from the upstream end. The discharge chute is fully concrete lined with a width varying from 65.5 m at the upstream end to 91.4 m at the downstream end. A concrete dissipater is located at the downstream end of the chute, where flows are discharged to the regulating pondage (figure 2).

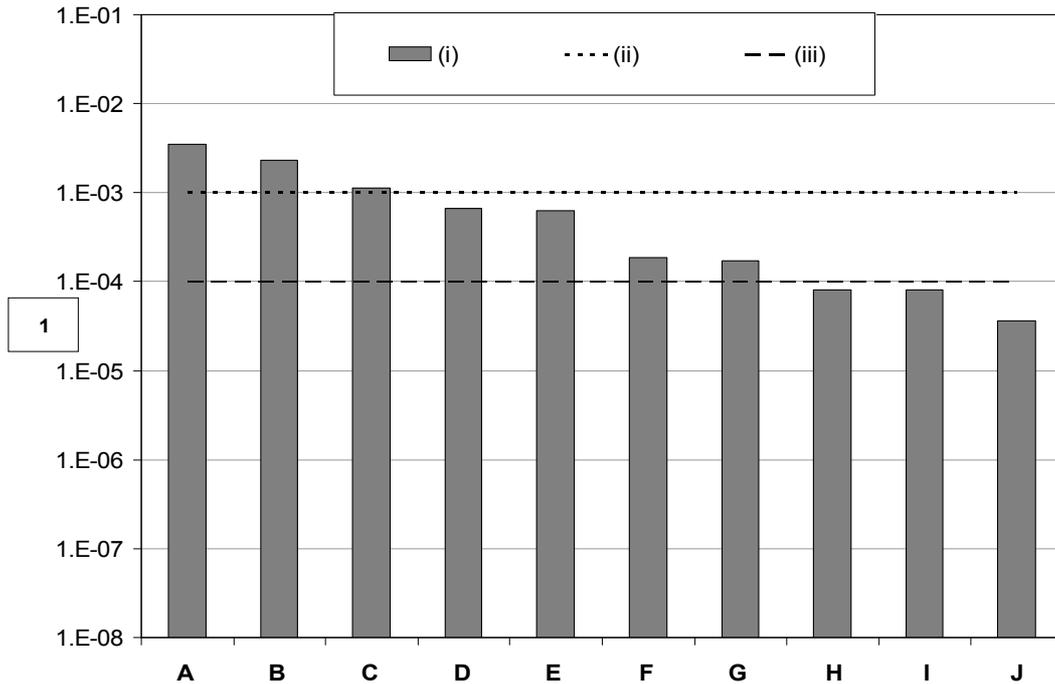
Figure 3
Risk Reduction Achieved by Work Elements
(Réduction des Risques atteint par les éléments des travaux)

i	Total Societal Risk Value	i	La valeur des risques à la société
ii	First Interim Target	ii	Premier objectif d'entre-temps
iii	Second Interim Target	iii	Deuxième objectif d'entre-temps
1	Societal Risk Value	1	La valeur des risques à la société
A	Existing Dam	A	Le barrage actuel
B	Filters, Crest RL291.65 (existing)	B	Filtres, Crête RL291.65 (actuel)
C	Filters, Crest RL294	C	Filtres, Crête RL294
D	Filters, Crest & Parapet RL296.9	D	Filtres, Crête et Parapet RL296.9
E	Chute Joint Repairs	E	Réparation du joint du coursier
F	Strengthen Toe Slabs & Walls	F	Renforcez les dalles et les murs du pied aval
G	Upgrade Gate Operating Gear	G	Améliorez l'équipement d'exploitation de la vanne
H	Anchor Spillway Structure	H	Installez le tirant de l'évacuateur de crue
I	Downstream Training Walls	I	Les murs guideaux d'aval
J	Raise Bridge, Piers & New Operating Gear	J	Levez le pont, les piles et le nouvel équipement d'exploitation

Figure 3 is a graph of estimated risk reduction that would be achieved as each element of the work is constructed. The upper horizontal line represents the first risk target used by the G-MW to prioritise dam safety works. It represents the limit of tolerability suggested by the Australian National Committee on Large Dams (ANCOLD) for existing dams. The lower horizontal line represents one order of magnitude less risk and is used as a guide for medium to long term staged risk reduction projects.

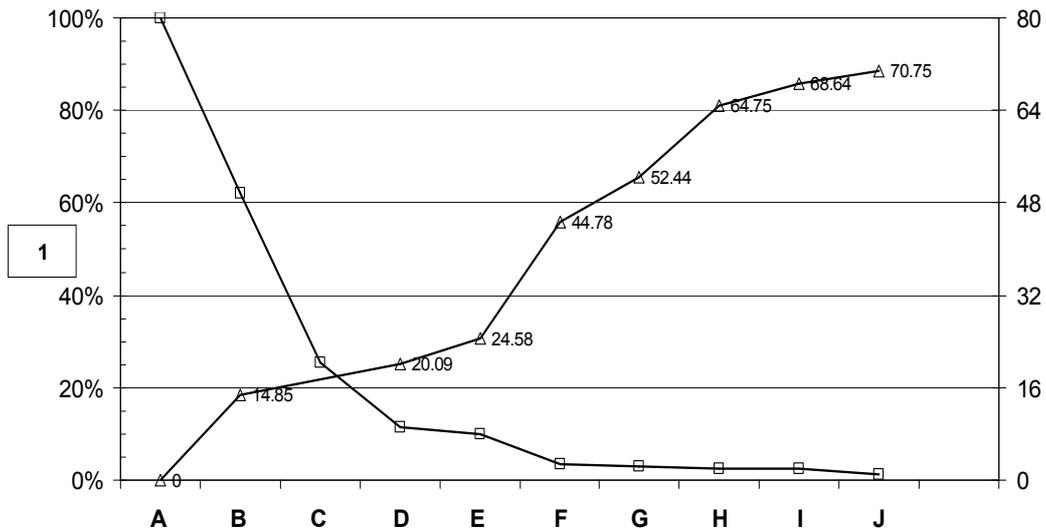
Figure 4
Risk Reduction vs Cost
(Réduction des Risques contre Coût)

1	Benefit (Percent of Original Risk)	1	Actif (Pourcentage des risques originaux)
A	Existing Dam	A	Le Barrage Actuel
B	Filters, Crest RL291.65 (existing)	B	Filtres, Crête RL291.65 (Actuel)
C	Filters, Crest RL294	C	Filtres, Crête RL294
D	Filters, Crest & Parapet RL296.9	D	Filtres, Crête et Parapet RL296.9
E	Chute Joint Repairs	E	Réparation du joint du coursier
F	Strengthen Toe Slabs & Walls	F	Renforcez les dalles et les murs du pied aval
G	Upgrade Gate Operating Gear	G	Aléliez l'équipement d'exploitation de la vanne
H	Anchor Spillway Structure	H	Installez le tyran de l'évacuateur de crue
I	Downstream Training Walls	I	Les murs guideaux d'aval
J	Raise Bridge, Piers & New Operating Gear	J	Levez le pont, les piles et le nouvel équipement d'exploitation

Figure 4 is a graph of percentage risk reduction achieved as each element of the work is constructed, along with the cumulative construction cost.

The review of risk reduction versus costs in Figure 4 indicated that the increments of risk reduction to be achieved by constructing additional works beyond the strengthening of the spillway toe slabs and chute walls were very small in comparison with costs of the additional works. However, the next works item to upgrade the operating gear was thought to be worthwhile as the operating gear was 50 years old and although significant risk reduction would not be achieved by upgrading, good practice indicated that the work should be considered.

The review of risk reduction in relation to the target levels of risk in Figure 4 indicated that the first risk target could be achieved by works to the main embankment only. However, this would only be by a small margin.
